Application of Modeling Techniques for Solving Misalignment Problem for Large Scale Pumping Stations

Sami Abd El-Fattah, Ibrahim R. Teaima, M. A. Hashim

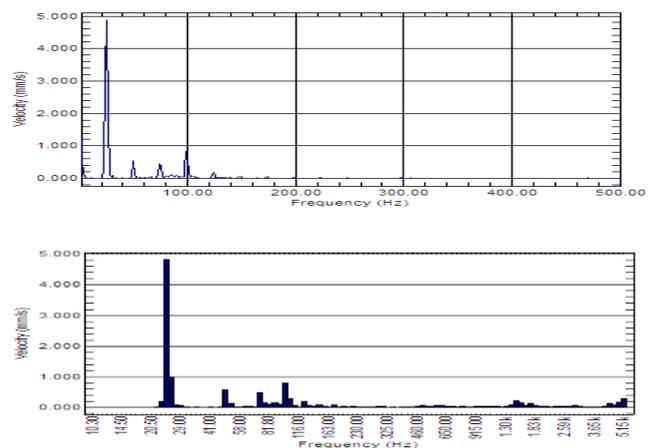
Fig. (3) (FFT) spectrum of angular misalignment at drive end in vertical direction (DE-V)

Angular misalignment generates a strong vibration at first order (1X), i.e., 1500 rev/min and some vibration at second (2X), i.e., 3000 rev/min in the axial direction. There has also been fairly strong radial (vertical and horizontal) first order and second order vibration levels. Vibration levels at drive end in danger according to ISO 10816-3. Measurements at the drive end showed that the maximum overall vibration level measured reached 6.45 mm/s and 4.2 mm/s in the axial and vertical directions respectively. These levels exceed the permissible levels by 1.8 times and 0.82 times on drive side.

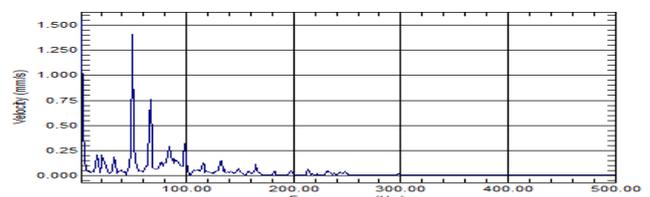
Fig. (4) (FFT) spectrum in horizontal direction

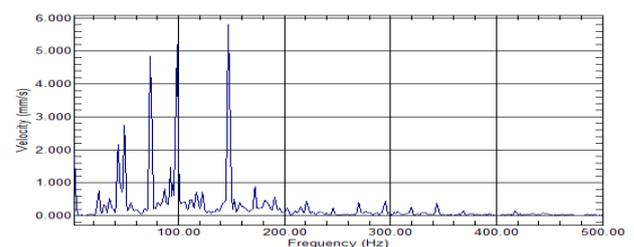
Fig. (5) (FFT) spectrum in axial direction.

The phase values in horizontal, vertical and axial directions across coupling as shown in Table (1). A phase difference 160° , i.e., $180^\circ \pm 30^\circ$ observed when axial measurements on the motor drive-end (MDE) bearing and DE bearing across the coupling. These results indicate that the angular misalignment present in the shaft. Misalignment causes an overload on bearings and results in shortening bearing life.

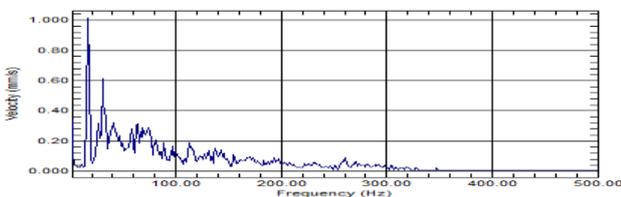
The spectrum of parallel and angular misalignment at (DE) balls in (V) values sees (Fig. 7), (H) values see (Fig. 8) and (A) values see (Fig. 9) are presented. FFT spectrum show that the higher amplitude at second order (2X), (3000 rev/min) in the radial direction acceptable range after alignment was done. After applying alignment process between motor and bearing, the results indicated that vibration Levels are within the acceptable range according to ISO 10816 -3 as shown in Table. (2).

Fig. (7) (FFT) spectrum of angular misalignment at drive end in vertical direction (DE-V)

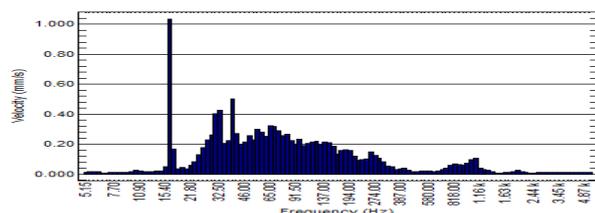
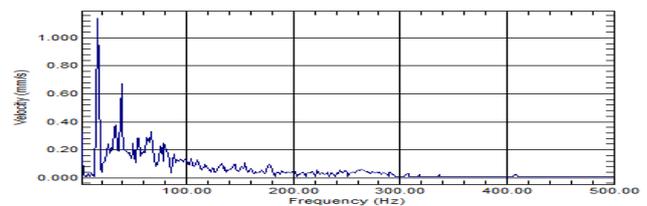
Fig. (8) (FFT) spectrum in horizontal direction

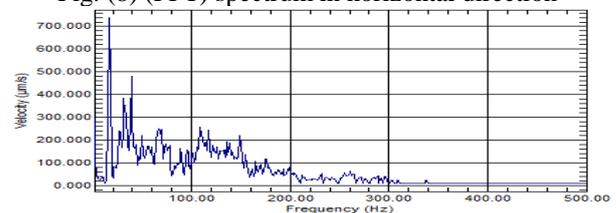
Fig. (9) (FFT) spectrum in axial direction

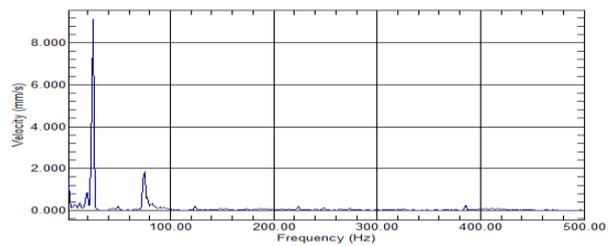
The (FFT) spectrum at DE balls in V values, Fig. (11), H values, DE-H Fig. (12) and axial direction, DE-A Fig. (13) are shown. FFT curves show that the bigger magnitude happens at first order (1X), i.e., 1500 rev/min. Vibration levels at motor drive end and gear box drive end sides are in danger according to ISO 10816-3.

Fig. (11) (FFT) spectrum of angular misalignment at drive end in axial direction (DE-A)

Measurements at the motor drive end showed that the maximum overall vibration level measured reached 4.25 mm/s and 13.75 mm/s in the axial and horizontal directions respectively. These levels exceed the permissible levels by 0.84 times and 4.09 times on the motor and gear box drive sides. The FFT curves mode that have been measured showed that, there are instability nodes appeared at unit rotating motion (1rev/min, 25Hz) in the axial and (V) values of the motor and pump. Vibration amplitude reached 4.25 mm/s, and 13.75 mm/s at the unit pinion end respectively in the axial and (H) values as shown in Fig.(11, 12 and 13). These high levels of vibration are in the danger area. The results indicated that the amplitude changed with directions. Also the amplitude in the axial direction is about 59 % of the biggest radial magnitude as showing in table (6). Depending on all these remarks, it is obvious that there is a misalignment problem. . Difference of phase observed between (H&V) direction on the balls is 99.5° i.e., $90^\circ \pm 30^\circ$. These results indicate the misalignment present in the system. Alignment process was done using (Laser Alignment device E530 with 2 Axis detectors from Easy Laser) and Alignment program (EASY TURN) to perform laser tilt and horizontal alignment between motor and gear box drive end. Measurements of overall vibration levels and frequency analysis are conducted and the FFT result confirmed that the vibration level became within acceptable condition after correcting misalignment deviation. Figures (14& 15 and 16) showing that the spectrums at drive-end balls of (V & H and A) and dynamic measurements are evaluated to determine the source of the high vibrations. After applying alignment process between motor and pump, the results indicated that vibration Levels are within the acceptable range according to ISO 10816 -3 as shown in Table (6).

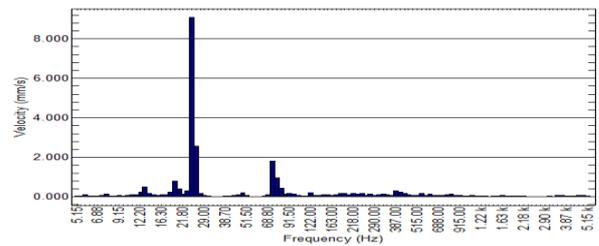
Fig. (12) (FFT) spectrum at drive end in horizontal direction (DE-H)

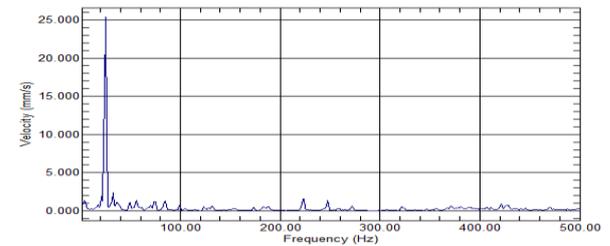
Fig. (13) (FFT) spectrum at drive end in vertical direction (DE-V)

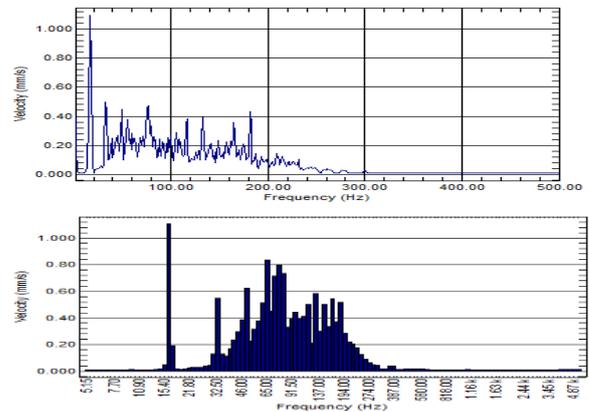
The measurements showed that the maximum overall vibration level measured reached 1.3 mm/s, 2.1 mm/s and 2.7 mm/s at rotor unit (DE). Overall vibration in Khayyam pump station level was decreased by 2.86 times in axial direction, 3.71 times in vertical direction and 4.09 times in horizontal direction after applying alignment process the natural frequencies in the cross-discharge direction are very close to the frequencies in the discharge direction. The analysis result confirmed that the vibration level became within acceptable healthy condition after correcting misalignment problem. Therefore this will be useful for extending pump running along the application of proactive maintenance scenarios.

Fig. (14) (FFT) spectrum at drive end in axial direction (DE-A) after alignment
