# Periodic Assessment and Long Term Durability Consideration of Drainage Galleries of Pandoh Dam, Himachal Pradesh, India using Non Destructive Test Method

S K Dwivedi, U S Vidyarthi, M Raja, C B Sarma

**Abstract-** Interaction of concrete with the persistent prevailing environmental condition will alter its material properties and cause deterioration. There are various causes of distress in the concrete structure, such as improper construction practices, post-construction expansion due to Alkali-Aggregate Reaction (AAR), corrosion of reinforcement, non-homogeneity of concrete, development of cracks due to shrinkage and thermal stresses, aging, etc. Such phenomena are very common in various elements of the dam. Pandoh dam is an earth cum rockfill dam 76.2 m high from the deepest foundation level. The dam is 255 m long and 12.19 m wide at the top, with a concrete spillway located on river Beas near Mandi in Himachal Pradesh. This dam was constructed in the year 1977 for irrigation and hydropower. Part of a run-of-the-river power scheme, it diverts the waters of the Beas to the south-west through a 38 km long system of tunnels and channels. The water is used for power generation at

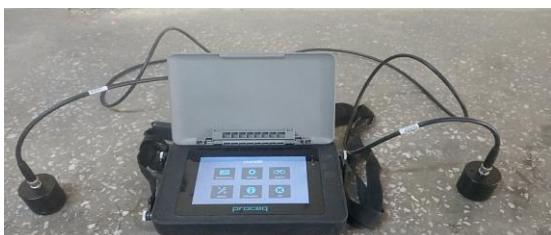
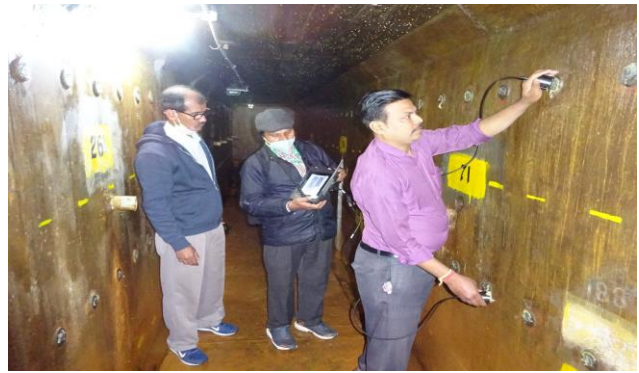
An electro-acoustical transducer in contact with one surface of the concrete under test generates pulses of longitudinal 'P' waves. A second transducer turns the vibrations pulse into an electrical signal after traveling a known path length (L) in the concrete. Electronic circuits allow the pulse's transit time (T) to be measured to be determined.

Figure 3.1: Ultrasonic pulse velocity test equipment (Proceq, Model- PL 200) and its application on drainage gallery walls

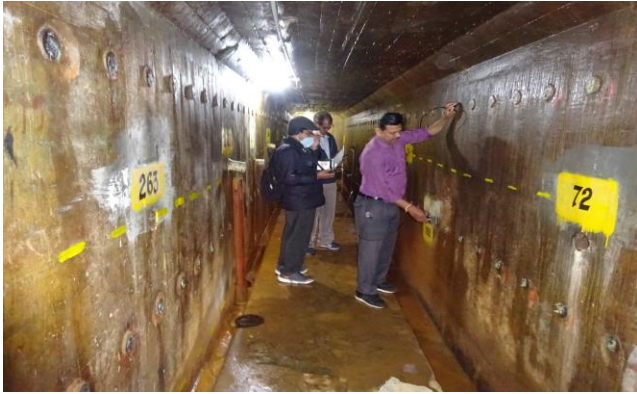
The ultrasonic pulse velocity measurements were performed on a drainage tunnel under a flip bucket at 201 test points with a 30 cm horizontal path length in two rows at a vertical distance of 100 cm on each of the upstream and downstream faces of the tunnel using an indirect method. It

was observed that 171 (85.07 percent) of the 201 test locations indicated that concrete quality is excellent, while 30 (14.93 percent) test locations indicated that concrete quality is good. The overall quality of concrete is excellent.

Figure 4.1: View of NDT testing at drainage tunnel under flip bucket

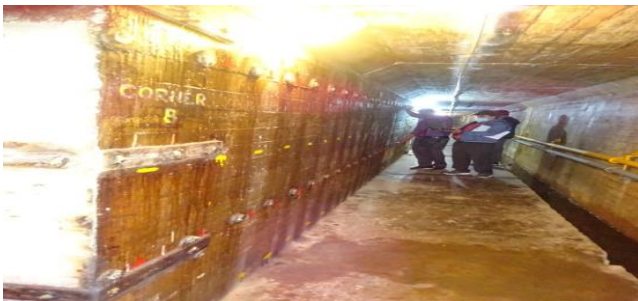
In the drainage tunnel under the spillway crest, ultrasonic pulse velocity tests were conducted by indirect method at 332 test points with 30 cm horizontal path length in two rows at a vertical distance of 100 cm. Out of 332 test locations, 86 (25.90 percent) indicate that concrete quality is excellent, 232 (69.87 percent) indicate that concrete quality is good, 12 (3.61 percent) suggest that concrete quality is doubtful. The remaining 2 (0.6 percent) test locations indicate poor concrete quality. The overall quality of the concrete is good.

Figure 4.2: View of NDT testing at drainage tunnel under spillway crest

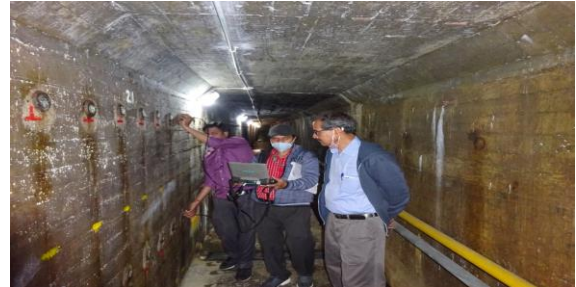
The ultrasonic pulse velocity tests were performed on a concrete wall under the spillway crest using an indirect method at 152 test points with a 30 cm horizontal path

length in two rows at a vertical distance of 100 cm. Out of 152 test locations, 35 (23.02 percent) indicate that concrete quality is excellent, 106 (69.73 percent) indicate that concrete quality is good, and 11 (7.23 percent) test locations indicate that concrete quality is doubtful. The overall quality of the concrete is good.

Figure 4.3: View of NDT testing at Concrete Wall from Block 168 to 174 under spillway crest

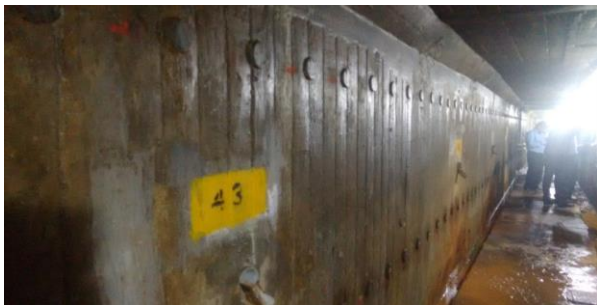
Ultrasonic pulse velocity measurements were conducted on the left abutment of the drainage tunnel at 573 test points with a 30 cm horizontal path length in two rows at a vertical distance of 100 cm on each of the tunnel's upstream and downstream faces using an indirect method. Out of 573 test locations, 93 (16.23 percent) indicate that concrete quality is excellent, 436 (76.09 percent) indicate that concrete quality is good, 37 (6.45 percent) indicate that concrete quality is doubtful. The remaining 7 (1.22 percent) test locations indicate poor concrete quality. The overall quality of the concrete is good.

Figure 4.4: View of NDT testing at drainage tunnel at left abutment

- Based on the UPV tests, the overall quality of in-situ concrete was observed to be good, and at those test points, wherever the quality of concrete was observed to be doubtful, it is suggested for continue monitoring of seepage water and determine dissolved Sulphate concentration.
- Apart from the above, assess the mineralogical content of leachate materials coming out along with seepage water. If the sulphate concentration exceeds the limit and the NDT test results indicate doubtful quality, extract a few cores from selective locations and determine their compressive strength and density to decide further action.
- Suppose spalling is observed in concrete exposing embedded reinforcement at doubtful locations, in that case, it is suggested to evaluate the extent of corrosion of reinforcement that has taken place in the entire area through the Half Cell Potentiometer.
