The Effects of Air Pollution on Damages in Historical Buildings, the Case of Gaziantep, Turkey

Tulay Karadayi Yenice

Index Terms— Air pollution, cultural heritage, conservation, Gaziantep, restoration.

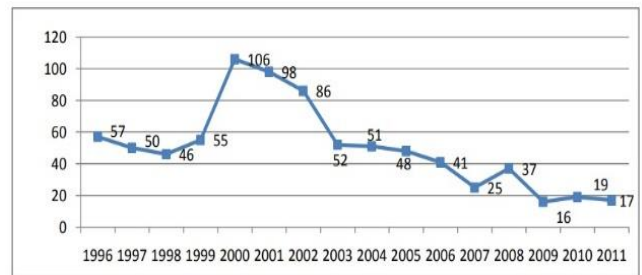
Chart 1. Annual average SO_2 change (1996-2011)

When the annual average SO_2 distribution of the last eight years is examined, it is seen that the average of the six years is above the threshold level set by the World Health Organization (Table 2). It can be said this value reached a high level for all years when examined during the winter season (Chart 1 and Chart 2).

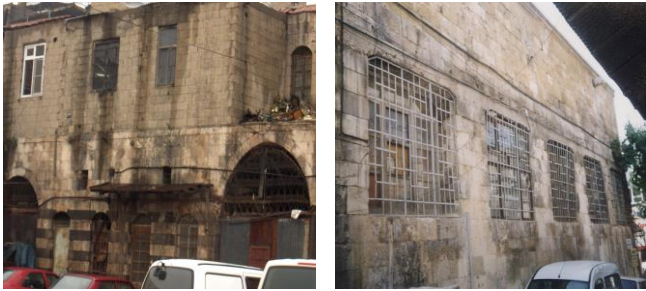
In measurements made on 29.11.2011, it is seen that the sulfur dioxide value of Gaziantep is $122 \mu\text{g}/\text{m}^3$. These findings indicate that the value of SO_2 increases especially in the winter months. The deterioration effects on the Gaziantep Historic Buildings due to air pollution can be seen in the form of color change, salt accumulation, crust formation and separation on the facades of the structures (Figure 2).

Figure 2. Examples of darkening - color change on the surface of a building

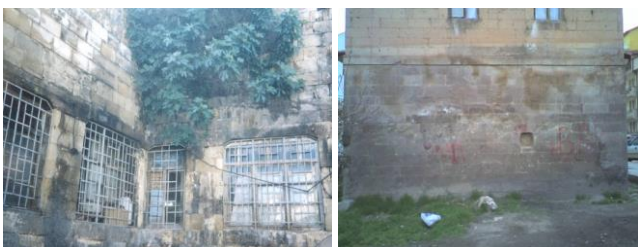
Liquid or solid materials in the atmosphere are particulate matters in air pollution [1]. It is known that particulate matter (PM₁₀) acts as a catalyst in the oxidation of SO₂ on the surface of a stone and plays an active role in the formation of gypsum minerals, as well as causing the building surface to darken. When air the measurement values of the city of Gaziantep is analyzed according to the PM₁₀ value, it can be said that it is quite high (Table 3). As a matter of fact, it is seen that the PM₁₀ value of Gaziantep is 143 µg / m³ in the measurements made on 29.11.2011.

These findings indicate that there is a high level of PM₁₀ in the air structure of the city. When the average annual PM₁₀ values of the city of Gaziantep are examined; according to the EU, World Health Organization and EPA norms (Table 4), this difference increases even more in winter. Deteriorations due to particulate matter in the buildings of the historical region of Gaziantep are seen as darkening on building facades (Figure 3).

Figure 3. Examples of darkening due to air pollution in building stones

particulate (PM10) matter. These minerals lead to the blackening of the building surface.

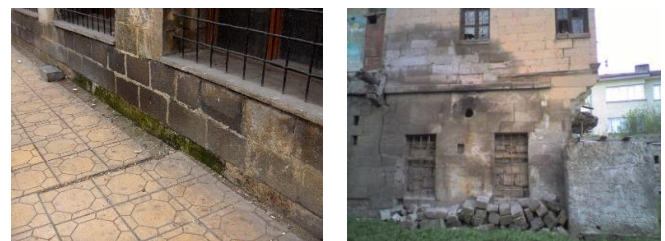
As a result, the surfaces where the rainwater is infiltrated and wetted the roofs, the wet areas formed by the water rising from the walls in regions where collecting the water around the building is insufficient, and the reaction and damage of the particulate matter and gases causing air pollution on the surface of the buildings can be seen in the historical buildings in Gaziantep. It is seen that dry surfaces are cleaner and healthier (Figure 4).

Figure 4. Wet areas on stone surfaces: color change, crusting, salt accumulation
