Cyclic Bending Failure of Local Sharp-dented 6061-T6 Aluminum Alloy Tubes

Abstract— This study presents an experiment for examining the degradation and failure of local sharp-dented 6061-T6 aluminum alloy tubes submitted to cyclic bending. The dent depths of circular tubes were considered from very trivial to approximately 0.6 times the tube's wall thickness. The moment-curvature response revealed an almost stable and closed hysteresis loop. The dent depths had almost no influence on the loop configuration. The ovalization-curvature behaviour demonstrated an asymmetrical and ratcheting trend along with the number of bending cycles. Furthermore, the deeper dent depths led to larger ovalizations. The relationship between the controlled curvature and the number of bending cycles required to ignite failure on a log-log scale displayed five nonparallel straight lines for five different dent depths. Finally, an empirical formula was introduced to simulate the relationship between the controlled curvature and the number of bending cycles required to produce failure. As a result, the experimental and analytical data were found to agree well.

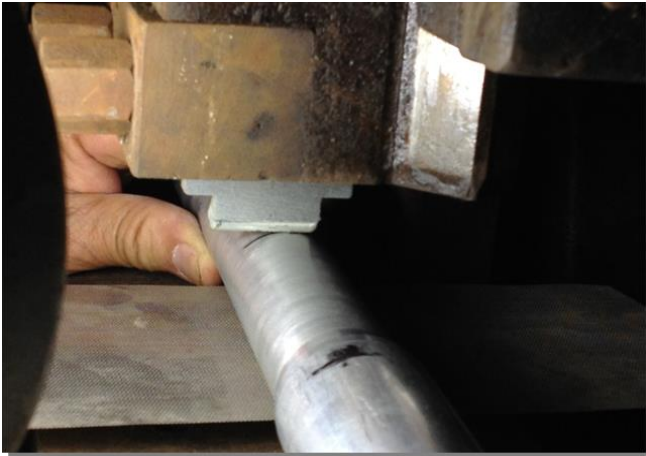
Fig. 3 A picture of processing a sharp dent on the 6061-T6 aluminum alloy tube

The original tubes with an outside diameter D_o of 33.0 mm and a wall thickness t of 2.0 mm were processed on the outside surface to create the expected dents. Figs. 3 and 4 show a picture and a schematic drawing of the dent production, respectively. The indenter contacted the outside surface and exerted a force F to create a dent. Four different dent depths (a) were considered herein: 0.3, 0.6, 0.9, and 1.2 mm.
